BY-LAW NO. 17802

A by-law to enter into a heritage revitalization agreement

# BROOKSDALE ESTATE, 19353-16 AVENUE, SURREY CONSERVATION PLAN

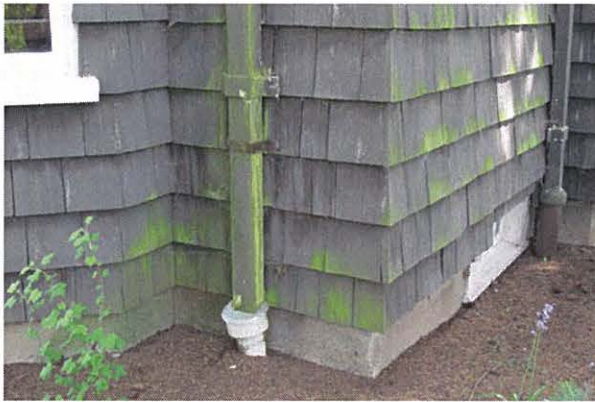
The wood-framed walls are clad in large cedar shingles with stucco and half-timbering in the gable ends. The house features several front-gabled dormers with stucco and half-timbering details. The condition of the shingles, stucco, and wood trim is good, however, the elements have had an effect on the original materials and areas of biological growth are evident throughout the building. Most walls show some wear to stain; the majority of damage appears cosmetic and can be easily remedied with proper maintenance. Due to water splashback and adjacent vegetation, wood siding located close to grade is slightly more deteriorated; siding location adjacent to drainpipes is also more deteriorated.

Biological growth on exterior walls (see the last bullet point of this section on page 18)

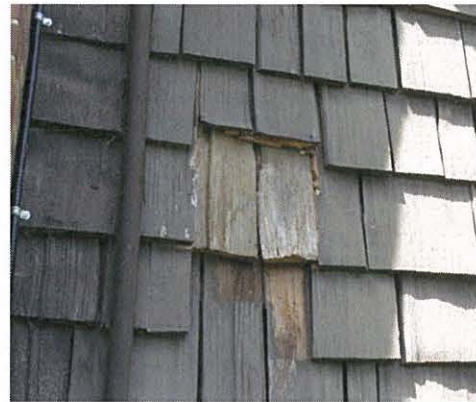
Missing shingles

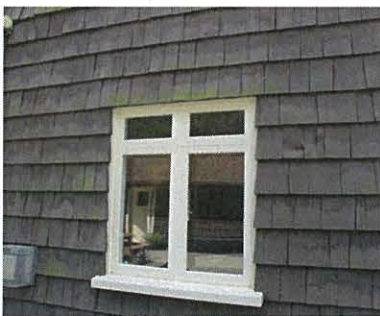
Wavy water damage visible

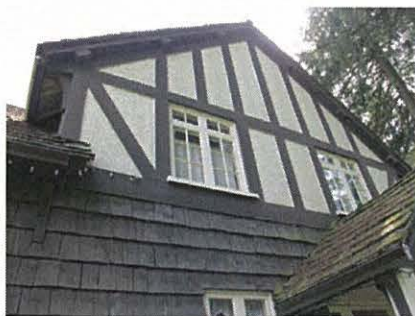
Wavy water damage visibly

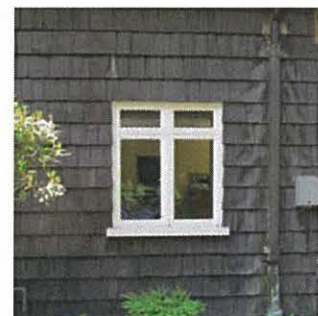
Damage by drainpipe visible

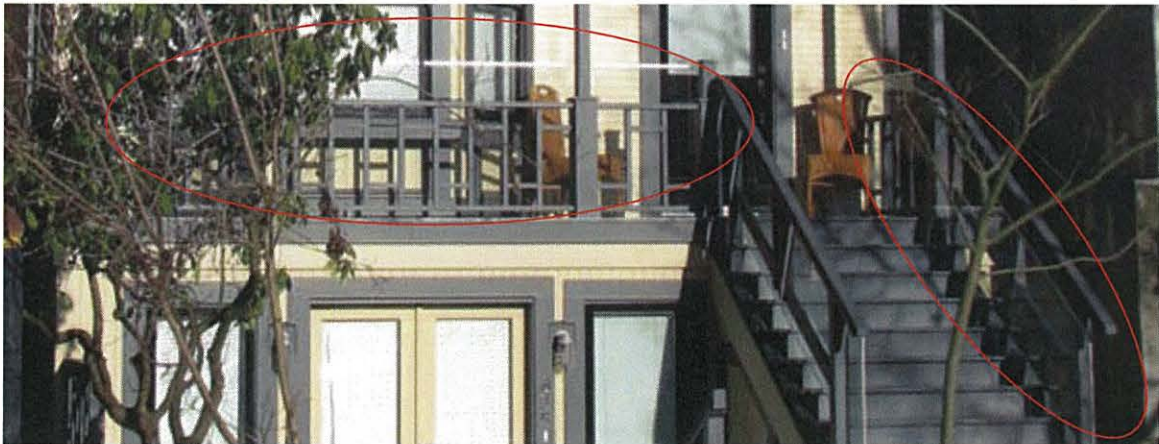
Code compliant balustrade, circled in red; the glass inserts are barely visible. A metal handrail installed on the staircase would also be a reversible and acceptable solution.

- The historic elements of the front entryway and brick steps will be preserved.
- The bricks appear to be in fair condition, though some repointing may be necessary along the risers and treads. If replacement of any bricks is necessary, ensure they are compatible in size and colour with the original.
- The original height of the balustrade will be retained. If an alternative means to reach the 42" code compliant height is required, this can be accomplished with a glass/plexiglass extension, or a metal or wood handrail (see example below).

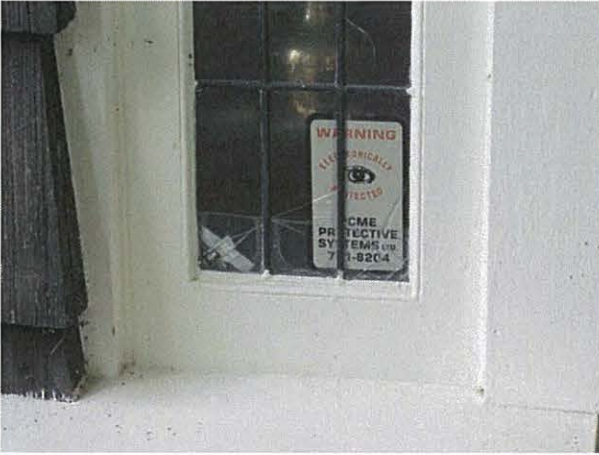
Close-up of the broken glass of the sidelight of the front door

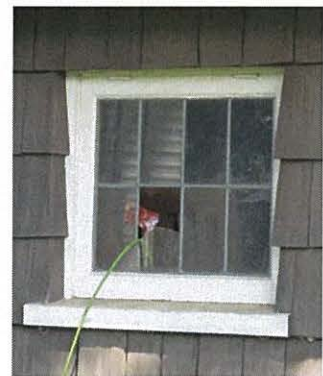
Broken window pane on south elevation

Most window openings on the Coach House feature original frames, sashes and single glazing, although some replacement windows are extant on the northeastern elevation. All incompatible/non-original windows should be replaced with new, wooden assemblies, including the frame, sash and sills, which are compatible in size, material, and design to the original windows present on the building. Original windows should be preserved and repaired, as necessary, which includes the broken window panes on the south elevation.

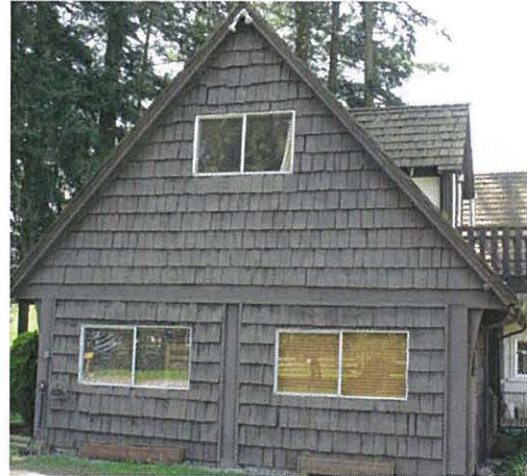
Non-original metal windows on the northeastern elevation, which should be replaced with more historically appropriate wooden frames and sashes

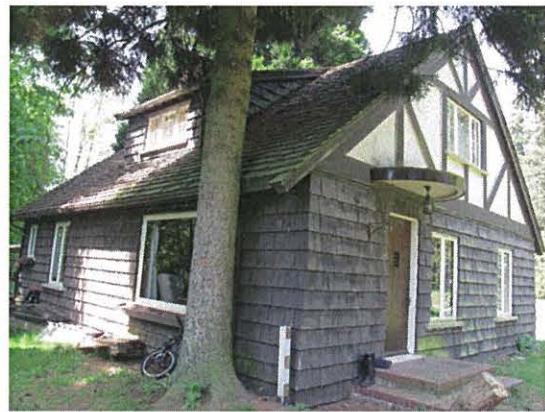
Tree on northeast corner, which should be removed

The foundation of the Caretaker's Cottage should be repaired and maintained, as necessary. Once the tree on the northeast corner of the cottage is removed, the foundation in this section should be examined and rehabilitated. The basement level of the cottage features windows that are not original to the construction of the building. These can be replaced as necessary.

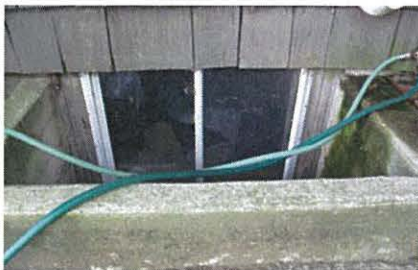
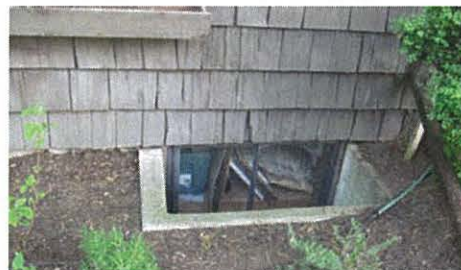
Foundation level of the Caretaker's Cottage, showing non-original windows, which can be replaced

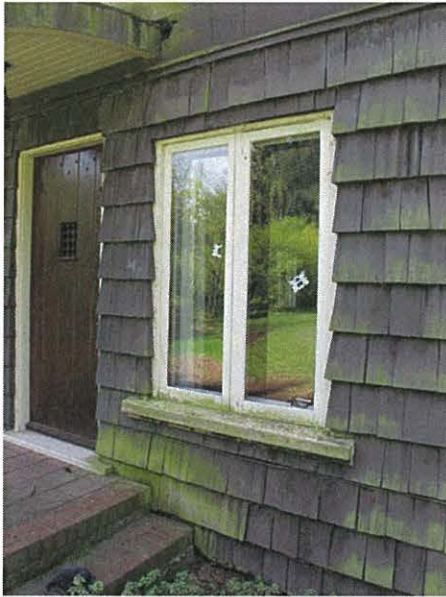
The wood-framed walls of the Caretaker's Cottage are clad in large cedar shingles, with stucco and half-timbering in the gable ends of the north and south elevations. The cottage features a shed roof dormer on both the east and west elevations. The shingles, stucco, and wooden elements are in generally good condition, however, the elements have had an effect on the original materials and areas of biological growth have accumulated on the north and east elevations. The majority of damage appears cosmetic and can be easily remedied with proper maintenance. Due to water splashback and adjacent vegetation, shingles located close to grade show higher levels of biological growth. The wooden window frame and projected sill on the north elevation is also suffering from deterioration due to biological growth.

North elevation: biological growth on shingles

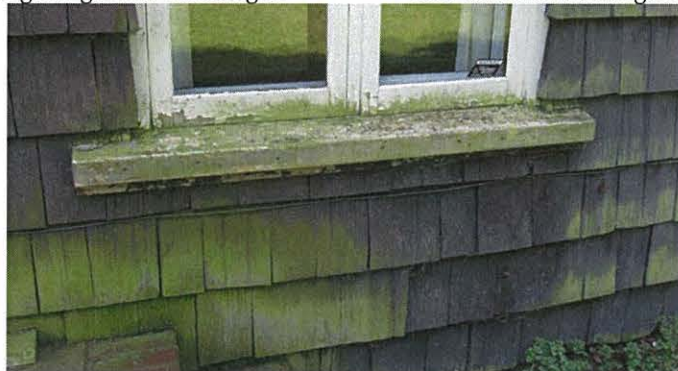
North elevation window frame and sill showing deterioration

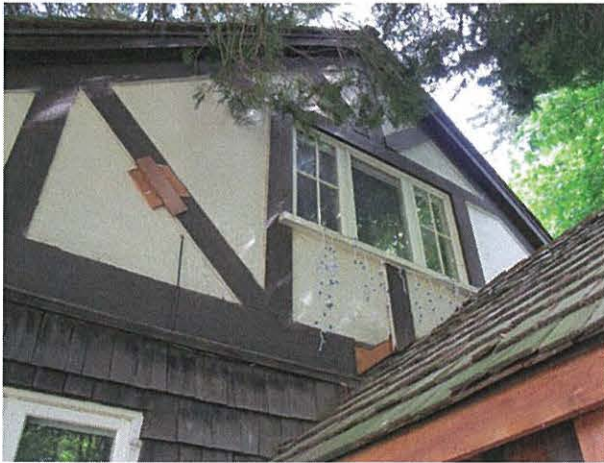
South elevation: half-timbering (to be repaired),  
wood trim and projected sill

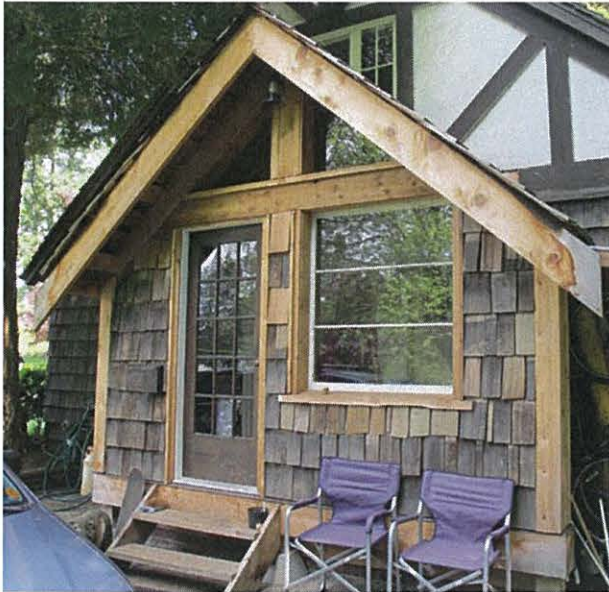
South elevation entryway addition:  
door, window, bargeboards, cornerboards and shingles  
should more closely match the remainder of the cottage

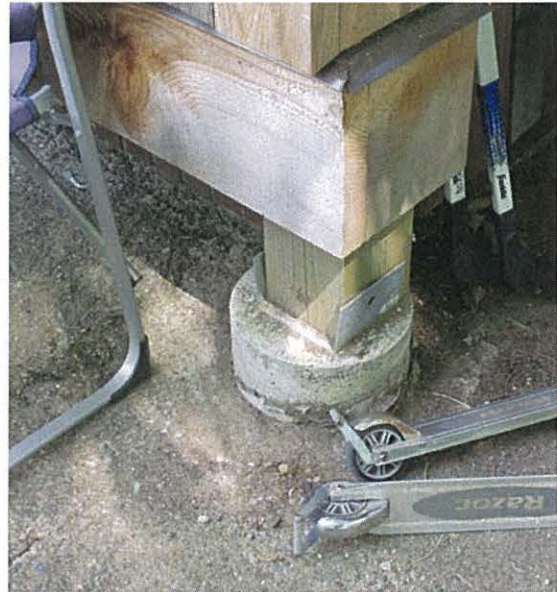
Void where brick steps should be extended

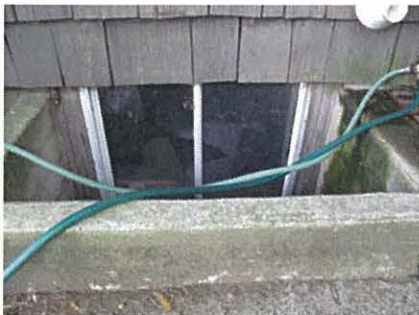
Replacement basement window

should be replaced with new, wood sash assemblies, which are compatible in size, material, and design to the original windows present on the building.

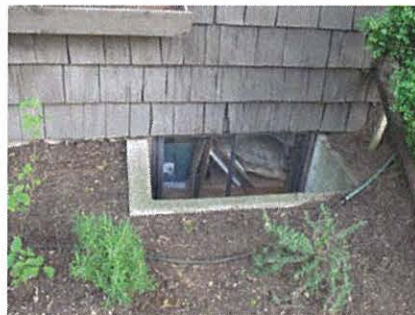
Replacement basement window
