BY-LAW NO. 17802

A by-law to enter into a heritage revitalization agreement

# BROOKSDALE ESTATE, 19353-16 AVENUE, SURREY CONSERVATION PLAN

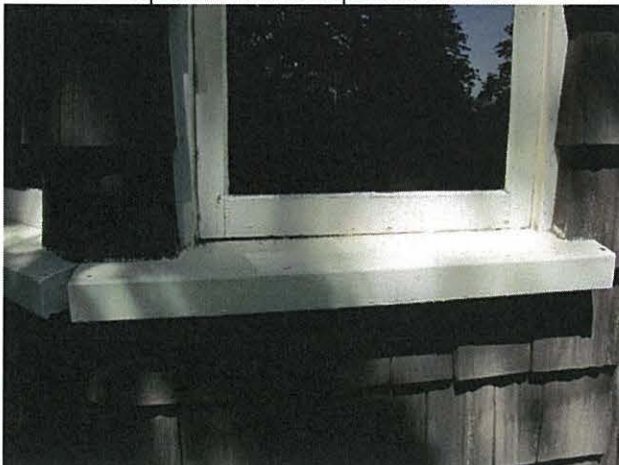
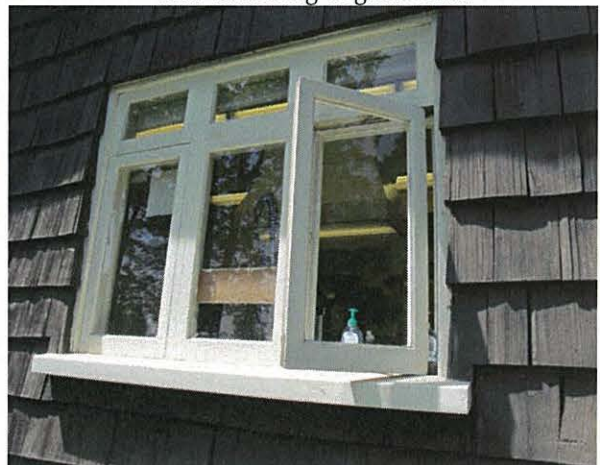
Example of window sills and frames

- Preserve existing exterior woodwork that is in good condition.
- Repair and replicate deteriorated decorative wooden elements based on physical evidence.
- If necessary, replace missing decorative woodwork to match existing, including window and door trim.
- Substitute materials such as Hardie Board or combed or textured lumber are not acceptable for replacement of any woodwork on the historic house.

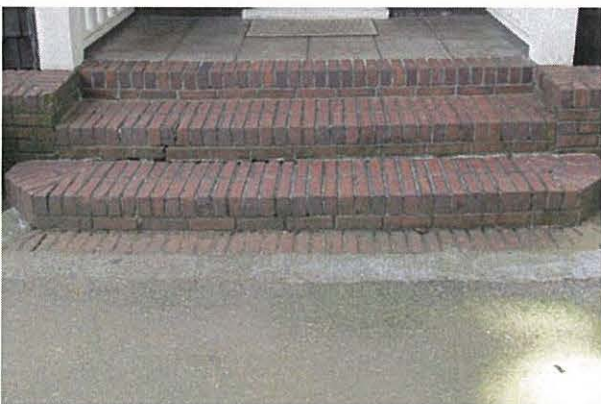
Detail of red brick steps

- The historic elements of the front entryway and brick steps will be preserved.
- The bricks appear to be in fair condition, though some repointing may be necessary along the risers and treads. If replacement of any bricks is necessary, ensure they are compatible in size and colour with the original.
- The original height of the balustrade will be retained. If an alternative means to reach the 42" code compliant height is required, this can be accomplished with a glass/plexiglass extension, or a metal or wood handrail (see example below).

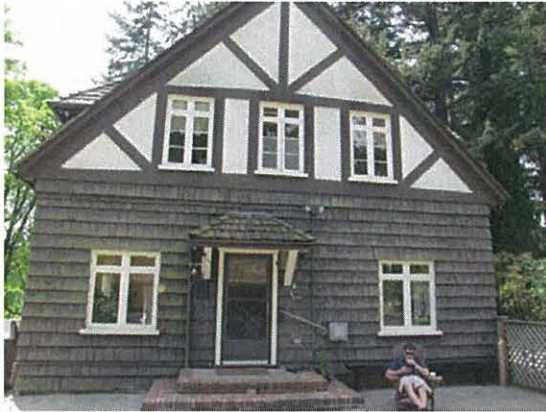
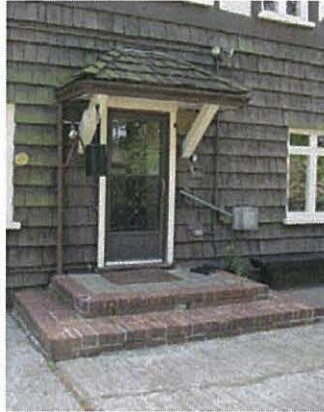
Side Entryway, north façade

Close up of north entry

- The historic elements of the side entryway and brick steps will be preserved.
- The original door will be preserved in situ.
- The bricks appear to be in fair condition, though some repointing may be necessary along the risers and treads. If replacement of any bricks is necessary, ensure they are compatible in size and colour with the original.

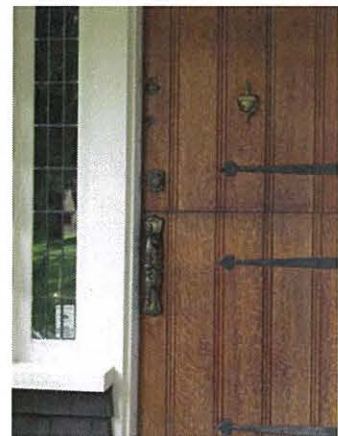
Sidelight of the front door assembly

- The leaded glass sidelights of the front door are significant character-defining elements and should be carefully repaired, where needed. The broken glass should be carefully removed by an expert and replacement glass, compatible with the original, should be installed. Due care should be taken to ensure the leading is not damaged.

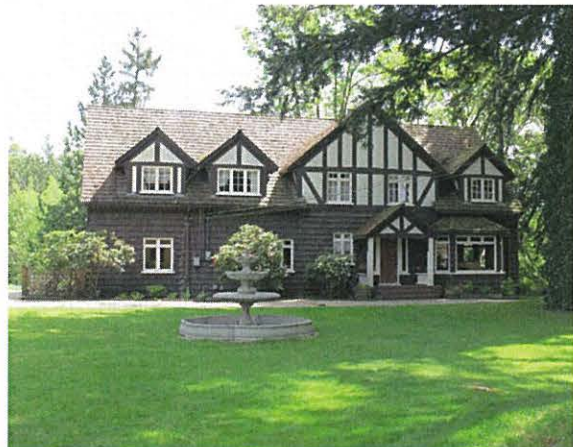
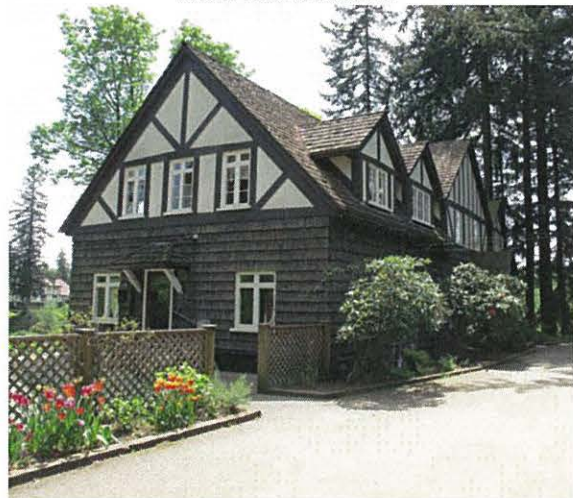
Main roof structure

Roof structure from north

- The original roof structure of the Brooksdale Estate is a significant architectural element and will be preserved.
- The current roofing material was recently assessed and reported to be in good condition; it does exhibit heavy tree needle collection and some biological growth. When replacement of the roofing material is required in the future, cedar shingles are the preferred roofing material.

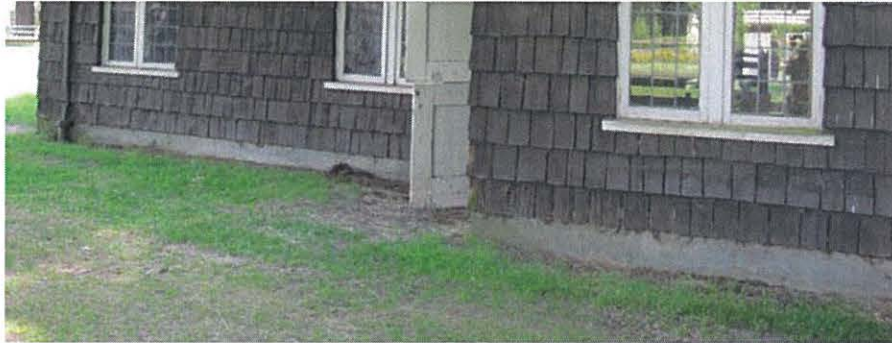
Coach House Foundation (west elevation)

- Preserve the foundation of the Coach House and repair and maintain it as necessary.

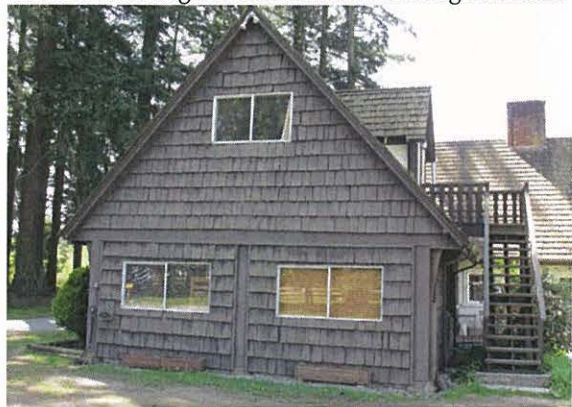
The wood-framed walls of the Coach House are clad in large cedar shingles, with stucco and half-timbering in the gable ends of the north and east elevations. The north elevation features stucco cladding at the building's northeast entrance and wooden lapped siding along the former stables. The building also features several front-gabled dormers with stucco and half-timbering detailing. The shingles, stucco, and wooden elements are in good condition, however, the environment has had an effect on the original materials, and areas of biological growth are evident throughout the building. Most walls show some wear, though the majority of damage appears cosmetic and can be easily remedied with proper maintenance. Due to water splashback and adjacent vegetation, wood siding located close to grade is slightly more deteriorated; siding located adjacent to drainpipes is also more deteriorated. Non-intrusive design interventions, such as a landscape rock bed, could prevent further deterioration. This is especially important on the northeastern elevation, in order to address pressing drainage concerns.

Northeastern elevation

- Any siding that is deemed to be rotten or too damaged/deteriorated for rehabilitation should be replicated and reinstalled to match the original.
- Substitute materials such as Hardie Board or combed or textured lumber are not acceptable for replacement of any woodwork on the historic Coach House.

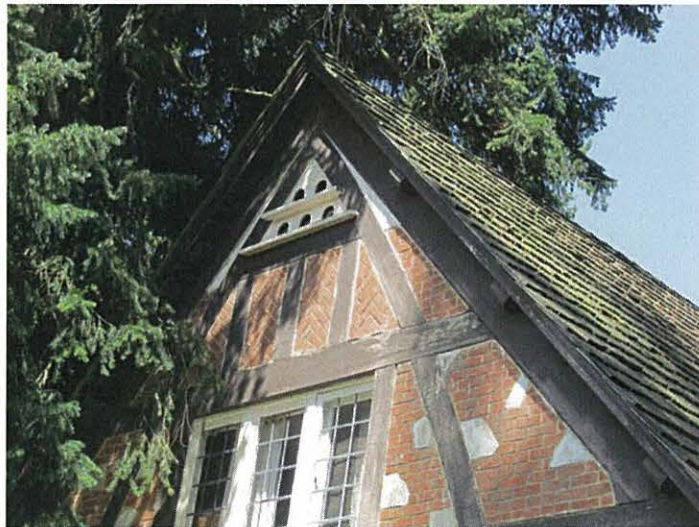
South elevation gable end detail

- Preserve the bricks, stones and half-timbering detailing in the gable-end.
- Any material that is deemed to be too damaged/deteriorated for rehabilitation should be replicated and reinstalled to match the original.
- Substitute materials such as Hardie Board or combed or textured lumber are not acceptable for replacement of any woodwork on the historic Coach House.
- The elevation should retain its historic appearance.
- Preserve or restore all architectural details as outlined in the character-defining elements section of the Statement of Significance.
- Design structural or seismic upgrades, if required, so as to minimize the impact to the character-defining elements.

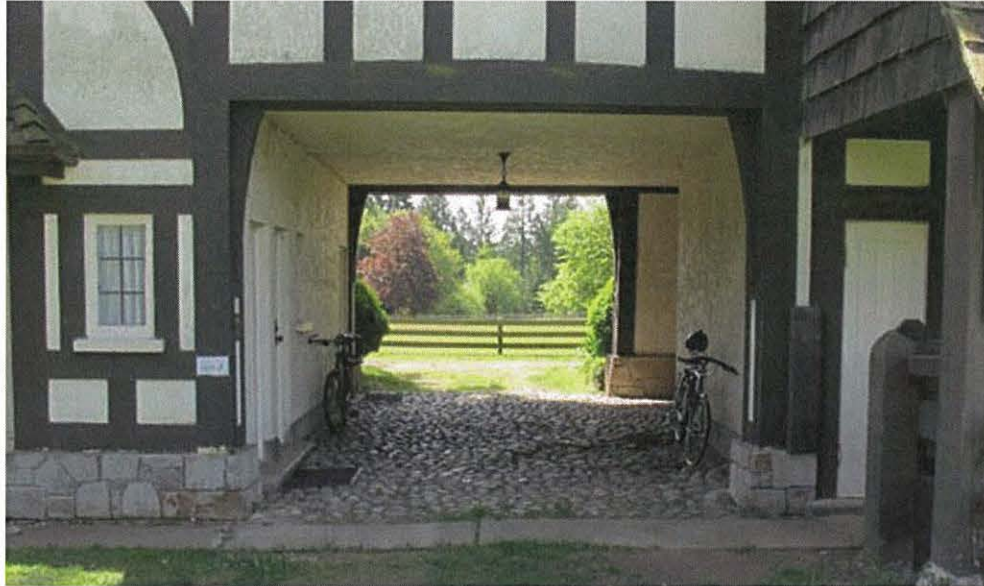
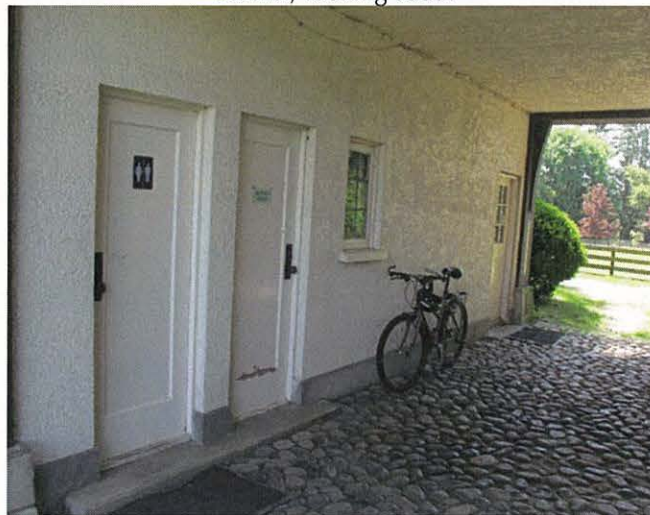
Tunnel, looking south

Tunnel interior

- Preserve and repair as necessary the stucco walls and ceiling, granite stone foundation at the entrance, and cobblestone pathway.
- Any material that is deemed to be too damaged/deteriorated for rehabilitation should be replicated and reinstalled to match the original.
- The tunnel should retain its historic appearance. Historic doors and windows in the tunnel should remain in place. Repairs should be made as necessary.

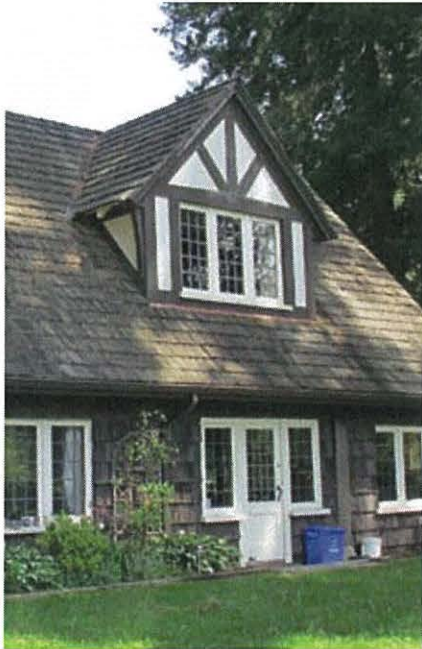
The south entryway features its original wooden door, along with its two original sidelights. This entryway should be preserved. The east entryway features a front-gabled roof structure, wooden columns and balustrades; none are original to the building. This entryway can be restored to echo the appearance of the main entryway of Brooksdale's main house. The northeastern entryway features an historic door and patio area, which should be preserved and repaired as necessary.

South elevation entryway

- The south elevation entryway should be preserved, including the original door and sidelights, which should be repaired as necessary.
- The east elevation entryway is not original to the building and can be restored to echo the appearance of the main entryway to the main house. If executed, the restoration of the entryway should include an historically appropriate front-gabled roof, columns and balustrades, similar to those on the main entryway of the main house, pictured below. Solid wood should be used, as Hardie Board or combed or textured lumber are not acceptable materials.

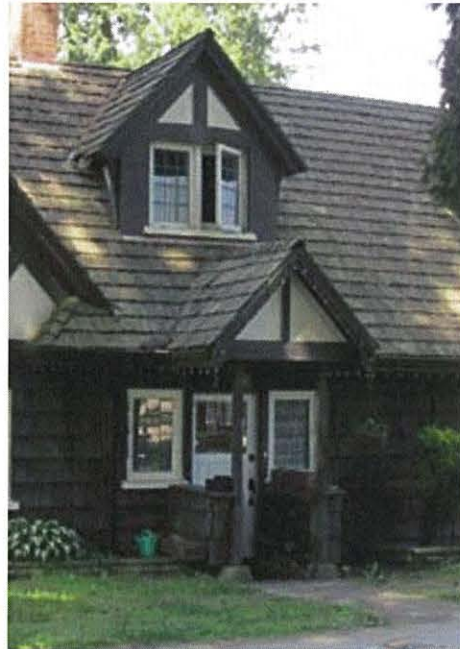
East elevation entryway

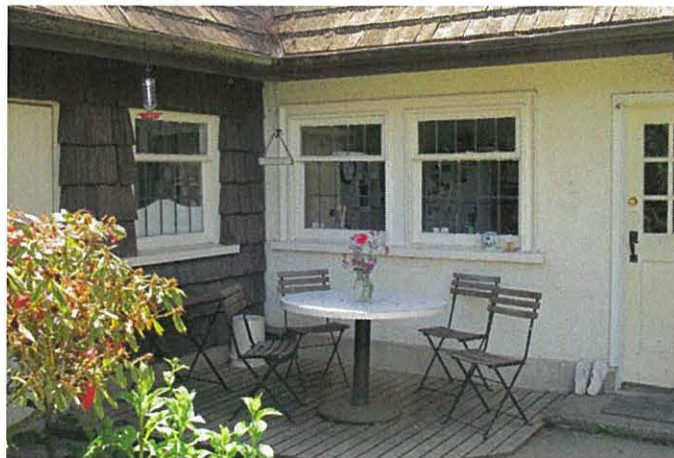
Northeastern entryway

- Preserve the historic door and patio area at the northeastern entryway.

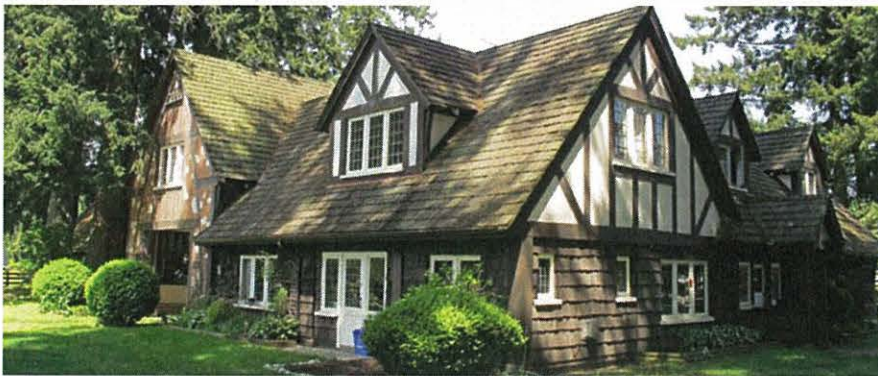
Most window openings on the Coach House feature original frames, sashes and single glazing, although some replacement windows are extant on the northeastern elevation. All incompatible/non-original windows should be replaced with new, wooden assemblies, including the frame, sash and sills, which are compatible in size, material, and design to the original windows present on the building. Original windows should be preserved and repaired, as necessary, which includes the broken window panes on the south elevation.

Original windows on the south and east elevations

- Remove/repair deteriorated, chipping, and rotten wood elements and match them to the profile of the original, historic windows.
- Review the condition of all original windows and repair where required. Remove loose paint. Remove decayed glazing putty and protect glass from damage. Following repairs, reputty original glass. If any glazing is damaged, replace with single-pane glass. Repair and resecure loose elements such as joint by doweling, gluing or attaching metal angles.

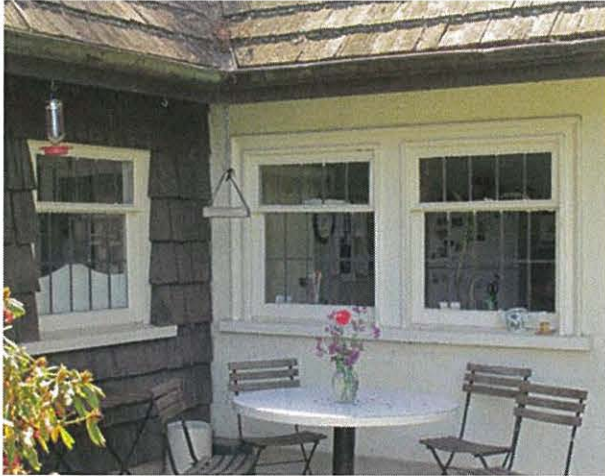
Original windows in the northeastern entryway area  
Broken window pane on south elevation

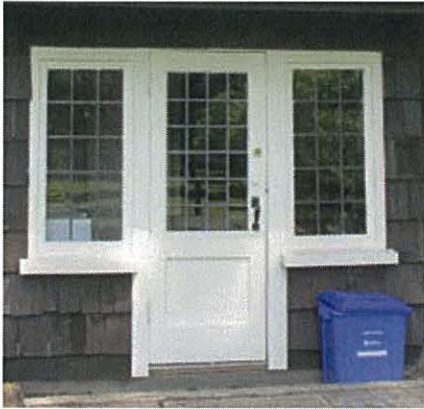
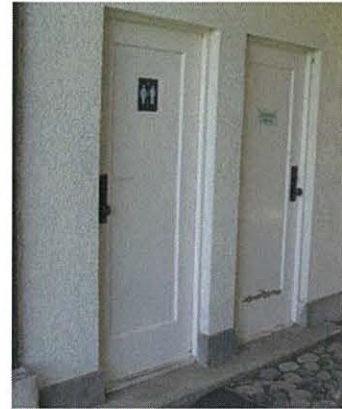
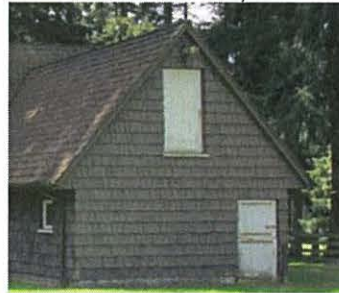
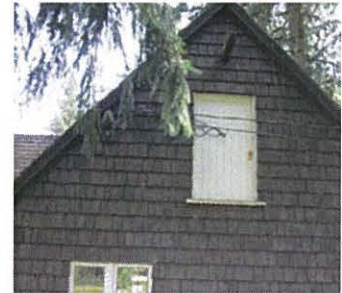
Most of the wooden doors on the Coach House are historic and original to the construction of the building. They should be preserved and repaired as necessary. The wide variety of doors includes entry doors and stable doors. Entry doors feature glazing, while the others do not. Any new doors required as part of the rehabilitation of the Coach House should be designed in an historically appropriate way.

- Preserve all original doors on the Coach House. Repairs should be made as necessary, following the least intrusive method possible, as to not further damage any element of the assembly.

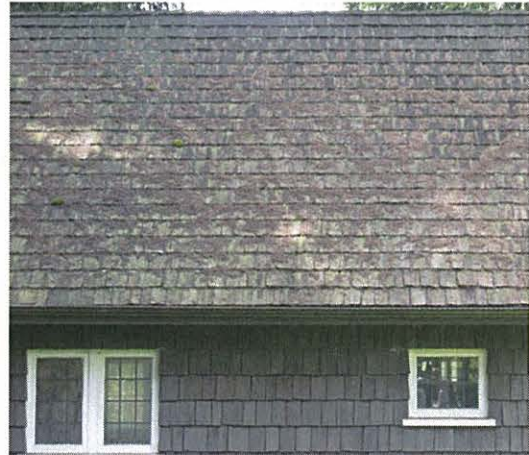
Needle cover on roof

- The original roof structure of the Coach House should be preserved.
- The current roofing material is in fair to good condition and exhibits some biological growth. When replacement of the roofing material is required, cedar shingles are the preferred roofing material.
- Review rainwater disposal system. If necessary, design and install adequate rainwater disposal system and ensure proper drainage from the site.
- Due to the presence of many mature trees in the close vicinity, it is imperative that the roof be cleaned of any biological accumulation twice a year (spring and fall). The drainage system should be cleaned during these times as well.
- The chimneys are prominent features of the Coach House and should be preserved.
- Do not apply sealants or consolidants to the exterior brickwork without review by the heritage consultant. Originally, bricks would not have been painted.

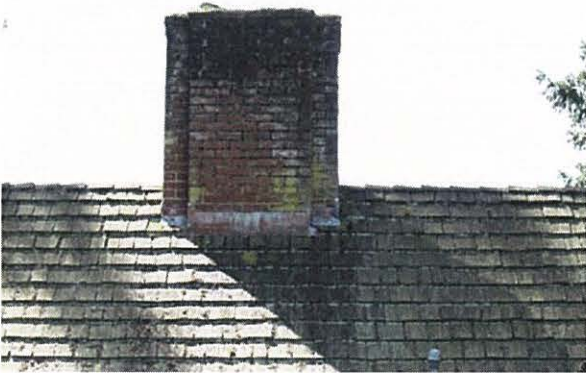
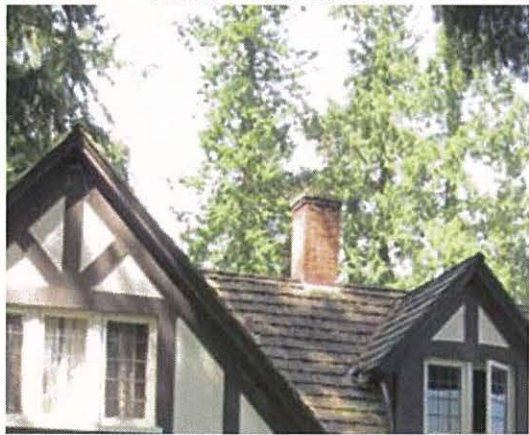
Original interior brick chimney on east-west ridge

East elevation interior brick chimney

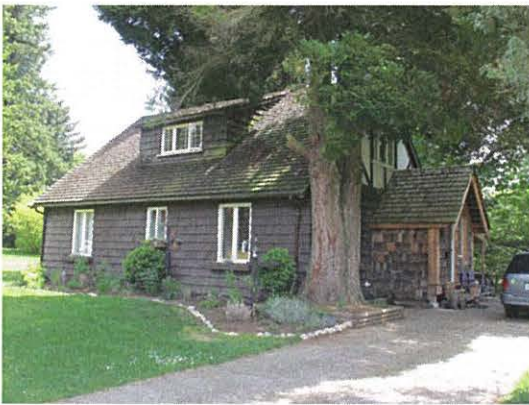
The Caretaker's Cottage house was constructed soon after the Main House, which was built in 1933. The Caretaker's Cottage will be preserved in situ and rehabilitated. The building is located along the site's access driveway, southwest of the Main House and southeast of the Coach House. The tree located on the northeast corner of the cottage should be removed, as it is jeopardizing the integrity of the structure.

Southwest view of the Caretaker's Cottage

- Preserve the Caretaker's Cottage in-situ. Remove the tree on the northeast corner of the building. This action is essential to the sustained life of the Cottage. Removal of the tree should be done carefully to ensure no additional structural damage is caused to the house. Once removed, the condition of the house should be assessed and any required repairs made.

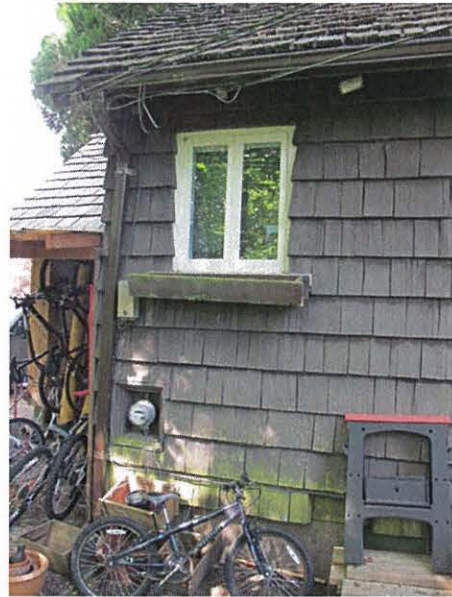
The wood-framed walls of the Caretaker's Cottage are clad in large cedar shingles, with stucco and half-timbering in the gable ends of the north and south elevations. The cottage features a shed roof dormer on both the east and west elevations. The shingles, stucco, and wooden elements are in generally good condition, however, the elements have had an effect on the original materials and areas of biological growth have accumulated on the north and east elevations. The majority of damage appears cosmetic and can be easily remedied with proper maintenance. Due to water splashback and adjacent vegetation, shingles located close to grade show higher levels of biological growth. The wooden window frame and projected sill on the north elevation is also suffering from deterioration due to biological growth.

East elevation: biological growth on shingles

- Any siding that is deemed to be rotten or too damaged/deteriorated for rehabilitation should be replicated and reinstalled to match the original.
- Substitute materials such as Hardie Board or combed or textured lumber are not acceptable for replacement of any woodwork on the historic cottage.

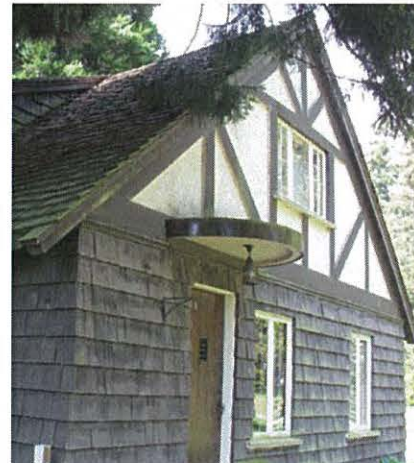
North elevation: bargeboards,  
half-timbering, wood trim and projected sills

- Preserve existing exterior woodwork that is in good condition.
- Repair deteriorated wooden elements based on original, well preserved sections. This includes the damaged/missing half-timbering sections on the south elevation gable end, which should be repaired to match the existing, original sections.

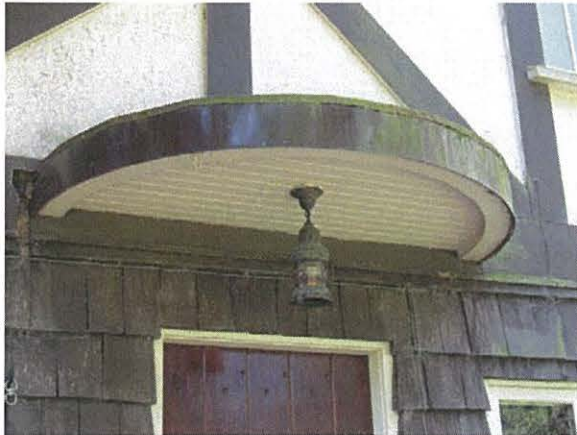
The north elevation entryway is original to the construction of the cottage and should be preserved and repaired, as necessary. The unique wooden door, semi-circular awning, and brick steps should all be carefully maintained, as they are character-defining elements of the cottage. There should be some consideration made regarding how to prevent biological growth from accumulating on the flat, top surface of the awning. Any solution must not impact the historic integrity or appearance of awning; if there is no long-term solution, the awning should be regularly cleaned and cleared of any growth or debris.

North elevation:  
semi-circular awning with hanging light fixture

- The north elevation entryway, including the original wooden door, semi-circular awning and brick steps, should be preserved and repaired as necessary.

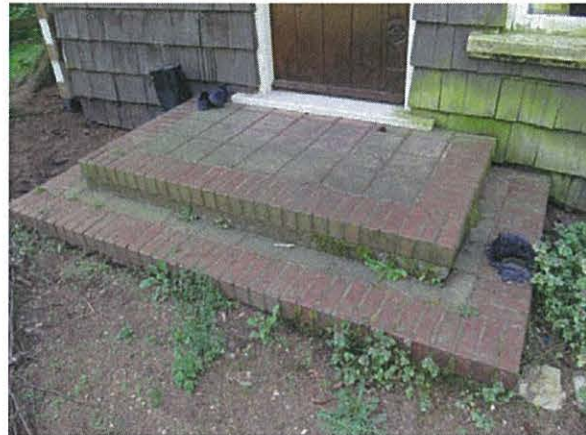
North elevation:  
brick steps

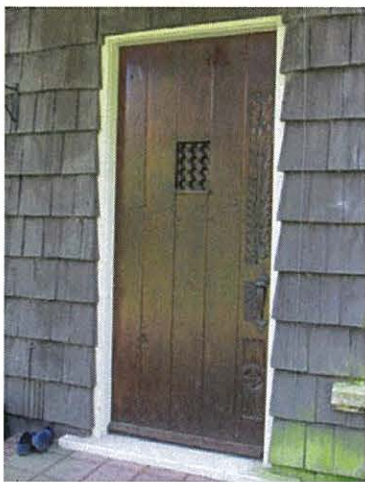
The south elevation door is not original to the cottage and should be replaced with a more historically appropriate door after the addition is rehabilitated. The door on the north elevation of the cottage is original and possesses a high degree of heritage value due to its intricate detailing. The door should be preserved and repaired, as necessary.

Original north elevation door

- Preserve the north elevation door in its original location. Repairs should be made as necessary, following the least intrusive method possible, as to not damage any element of the assembly.
- The south elevation door should be replaced with an historically appropriate assembly. Examples from Vintage Woodworks are pictured below:

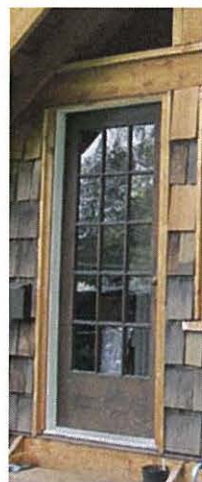
Current front door

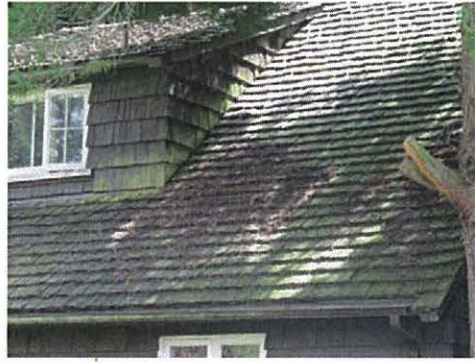
The front-gabled roof structure of the Caretaker's Cottage is original and is clad in cedar shingles. There is a shed roof dormer on both the west and east elevations. The roof appears to be in fair to good condition; however there is a significant amount of needle cover on the southwest corner. The addition on the south elevation is not original and will be rehabilitated to more closely match the historic appearance of the cottage. There is an internal brick chimney near the centre of the cottage that appears to be in good condition.

Needle cover on roof
